Aroostook Utility Assets Assessment

Village of Southern Victoria, NB

GEMTEC Project: 103013.002

February 26, 2024
GEMTEC Project: 103013.002

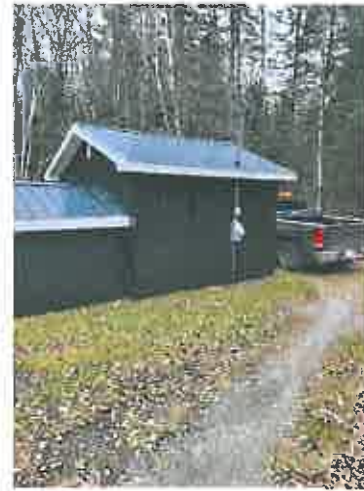
Well #2 Pumphouse

The system saw expansion in 1972 with the development of Well #2, which in turn feeds a 115,000 imperial gallon steel water tank (standpipe). At present, Well #2 stands as the primary water source for the community, with Well #1 serving solely as an emergency backup. Well #1, classified as a gravel well, has a production capacity of 40 gallons per minute, while Well #2, categorized as a rock well, boasts a higher output of 100 gallons per minute. The monitoring of turbidity levels at Well #2 is of particular importance, especially during periods of elevated runoff, ensuring the ongoing maintenance of water quality standards. Well #2 is "believed" to be GUDI (groundwater under the direct influence of surface water) but there is no special treatment for GUDI (ex. UV disinfection). UV was contemplated but not implemented because the water is quite hard, and UV would not be effective. The current water treatment is chlorination with sodium hypochlorite. Well #2 is equipped with a transfer switch for generator connection during power failures, ensuring uninterrupted service provision.

2. Enhance pump control by installing a more accurate electronic pressure switch for Well #2.
3. Address turbidity concerns by investigating the installation of a filtration system for Well #2. The new filtration system could be accommodated within the current well house.

4. Replace plastic piping with steel piping in the well house for Well #2, as proposed by the operator, for enhanced reliability.
5. Verify and develop a plan to act upon repairs recommended by Landmark concerning the water tank, as per the report received by the Village in 2022. This plan could have a risk matrix developed for the repairs required so they can be ranked in an order of priority.

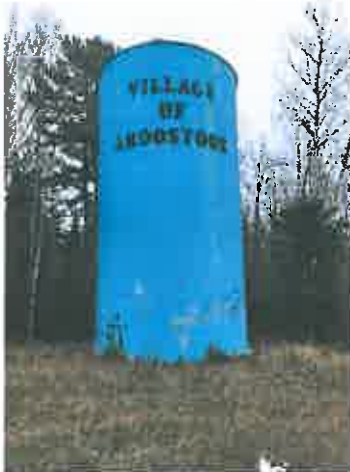
115,000 IG Steel Water Tank

The main water tank is a steel standpipe installed in 1972, with a capacity of approximately 115,000 imperial gallons and dimensions of 24 feet in diameter and 42 feet in height. The high-water level is at 40 feet and the filling process is regulated by a mechanical pressure switch maintaining pressure between 25 and 31 psi. The tank's last relining was in 1994. In July 2022, Landmark conducted a study encompassing the evaluation of interior and exterior coatings, identification of any corrosion on the interior surface, assessment of exposed foundation conditions, and recommendations for safety equipment upgrades, with the detailed report attached as Appendix A. Landmark's report includes a breakdown of the repairs required and of additional inspection requirements, with an estimated cost of approximately \$700,000.

Note: based on age proxy, the steel tank's condition would be considered, however, the tank requires repairs and upgrades, estimated at approximately \$700,000 based on Landmark's report.
