Subject: **Perth-Andover Crosswalk Review**
Englobe reference: 2112487.000

1 Introduction

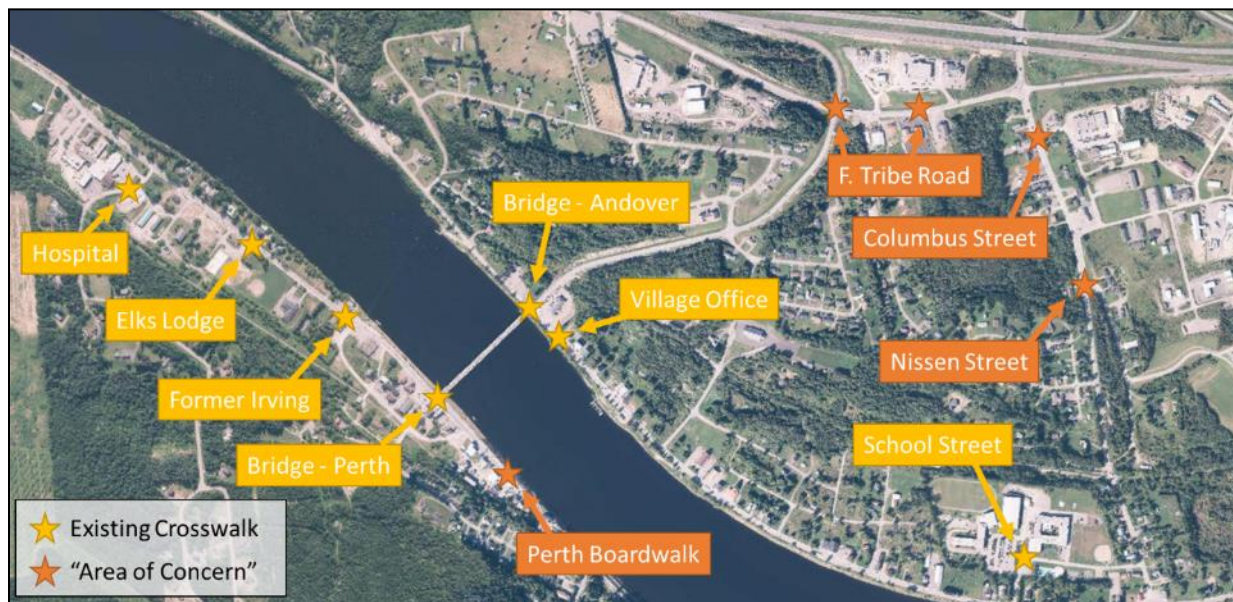
Figure 1: Study Locations

As part of the Village of Perth-Andover’s goal to become a more walkable community, the Village engaged Englobe Corp. to conduct an engineering assessment of 7 existing crosswalks and 5 “areas of concern” within the Village, as shown in Figure 1. The scope of the assessment varied depending on the location, potentially including reviewing the need for a crosswalk, recommending crosswalk alignments, recommending crosswalk treatments, and identifying sidewalk/trail infrastructure that could support improved crosswalk connections.

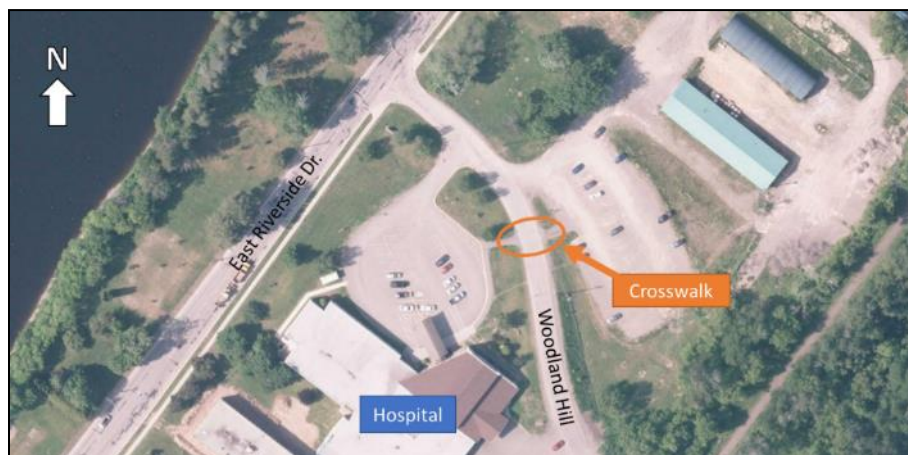
Figure 2: Hospital Crosswalk

This midblock crosswalk on Woodland Hill Road connects St. Joseph’s Hospital to a parking lot for the hospital. The crosswalk is marked with ground mounted signs (RA-4) and twin parallel line crosswalk markings with hatched lines between them, as shown in Figure 14 in Appendix A.

Based on the characteristics of the area, it does not appear that a marked crosswalk at the Hospital is merited. While the crosswalk sits on a clear pedestrian desire line (from the parking lot to the Hospital), conflicting vehicle volumes along Woodland Hill Road are expected to be less than 1,500 per day (the TAC threshold) and a crosswalk in this location does not provide a “system connectivity” benefit. **We recommend that the Hospital could crosswalk be removed.**

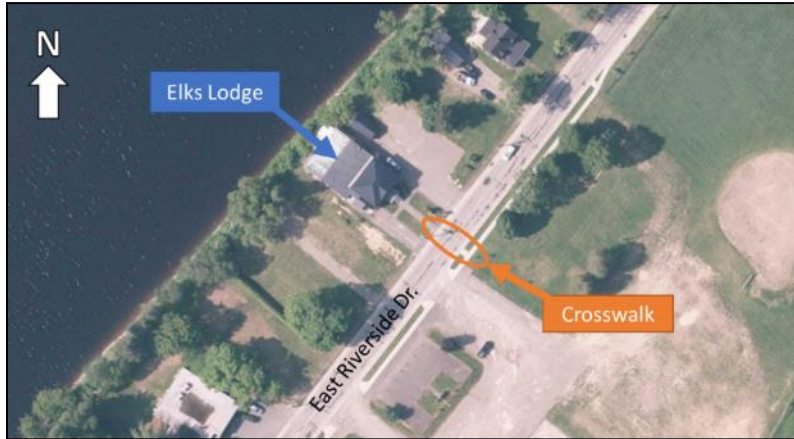
Figure 3: Elks Lodge Crosswalk

This midblock crosswalk on East Riverside Drive connects the Elks Lodge to a parking lot on the opposite side of the roadway. The crosswalk is marked with ground mounted signs (RA-4) and twin parallel line crosswalk markings with hatched lines between them, as shown in Figure 15 in Appendix A.

This location does not merit a marked crosswalk due to the low and infrequent volume of pedestrians who would cross the road at this location. **We recommend that the Elks Lodge crosswalk be removed.**

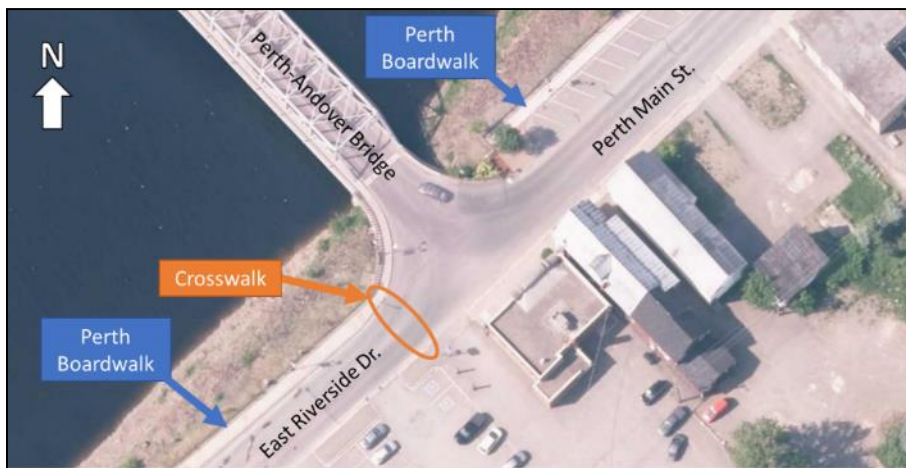
Figure 5: Bridge - Perth Crosswalk

This intersection crosswalk crosses East Riverside Drive on the south leg of the intersection and connects the sidewalk along the east side of the roadway to the Perth Boardwalk (to the south of the Bridge) and to the sidewalk that continues along the bridge into Andover. The crosswalk is marked with twin parallel line crosswalk markings with hatched lines between them and the intersection has stop signs on all three approaches, as shown in Figure 17 in Appendix A.

The location of this crosswalk is integral to connecting Perth to Andover and is conveniently located at an all-way stop controlled intersection. Ideally there would also be a crosswalk connecting the Perth Boardwalk across the west leg of the intersection; however, the large crossing distance due to the intersection geometry makes this impractical, particularly considering that the Province is exploring the replacement of the existing bridge. As a result, **we recommend that the Bridge - Perth crosswalk be maintained in its existing location with zebra markings.**

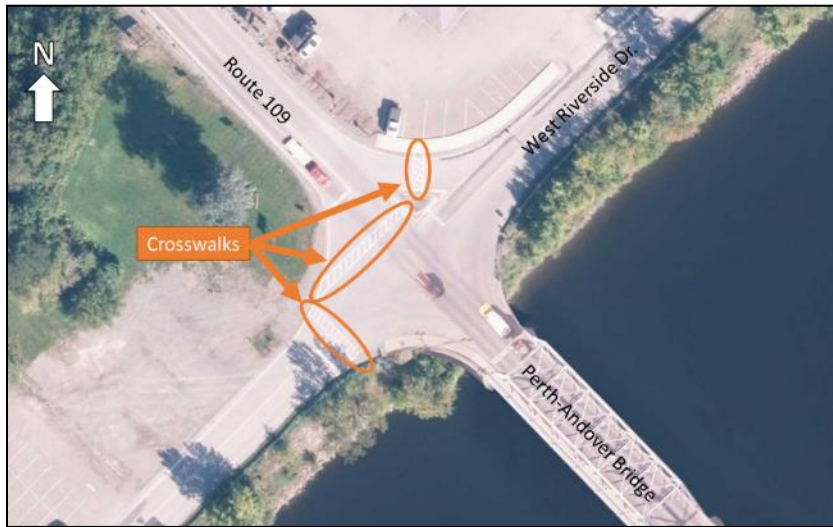
Figure 6: Bridge - Andover Crosswalk

This intersection has three marked crosswalks: one across West Riverside Drive on the south leg, one across Route 109 on the west leg, and one across the right turn channel. These crosswalks connect the sidewalk along the Perth-Andover bridge to the sidewalks that continue along the west side of West Riverside Drive to the north of the intersection and along the north side of Route 109 to the west of the intersection. These crosswalks are marked with twin parallel line crosswalk markings with hatched lines between them and the intersection has stop signs on all four approaches, as shown in Figure 18 in Appendix A.

Much like the crosswalks on the Perth side of the bridge, these crosswalks provide important system connectivity between the Perth and Andover sides of the Saint John River. As such, **we recommend that the Bridge - Andover crosswalks be maintained in their existing locations with zebra markings**. Additional improvements could be made to the intersection to improve pedestrian accessibility, including a paved pedestrian waiting area on the southwest corner of the intersection and converting the southbound right turn channel into a smart channel; however, with the potential replacement and realignment of the bridge these may not be sensible solutions for the long term.

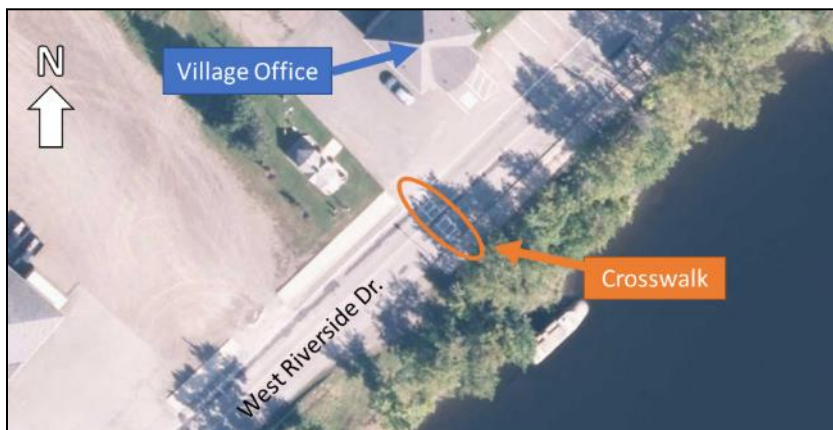
Figure 7: Village Office Crosswalk

This midblock crosswalk on West Riverside Drive bridges the sidewalk along the roadway which switches sides near the Village Office. The crosswalk is marked with twin parallel line crosswalk markings with hatched lines between them, as shown in Figure 19 in Appendix A.

The location of the Village Office crosswalk is important for connecting the existing sidewalk along West Riverside Drive. **We recommend that the Village Office crosswalk be maintained in its current location, with the addition of zebra markings and ground mounted signs (RA-4) to better delineate the crosswalk.**

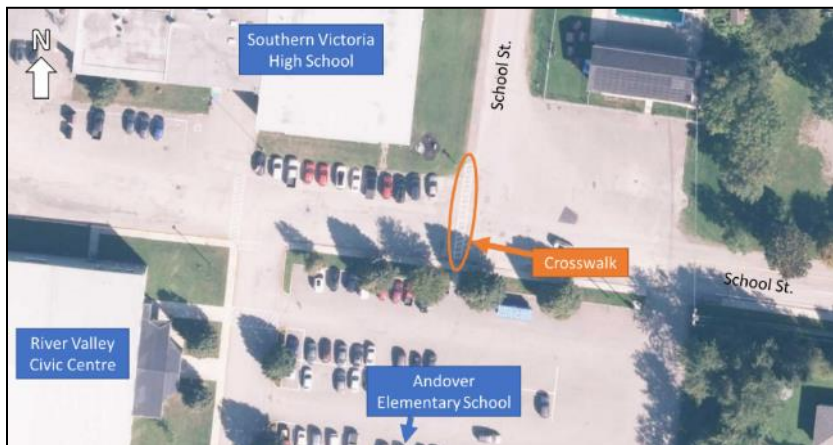
Figure 8: School Street Crosswalk

The school street crosswalk is at the intersection where School Street makes a 90 degree turn and adjoins with the access to Southern Victoria High School and Andover Elementary School. The crosswalk runs across the west leg of the intersection and is marked with ground mounted signs (RA-4) and twin parallel line crosswalk markings with hatched lines between them. The southbound approach to the intersection has a stop sign while the other two approaches have the right-of-way. Lastly, the area is in a school zone marked with a square variant of the school zone sign (WC-1) and a posted speed limit of 20 km/h along the length of School Street (from West Riverside Drive to Fort Road) , as shown in Figure 20 in Appendix A.

While the location of the crosswalk is important for providing safe access to/from the schools and community facilities in the area, **we recommend that the following improvements be made to the area to improve the safety of the crosswalk:**

- The school zone signage should be upgraded to follow TAC guidelines, including replacing the existing school zone signs (WC-1), using school crosswalk signs (RA-3) on both ends of the crosswalk, and using zebra markings instead of parallel crosswalk markings.
- The crossing distance should be made shorter by installing a curb extension on the northwest corner.
- A curb and raised buffer should be installed around the parking area for the pool to better delineate the intersection and reduce corner cutting by drivers.

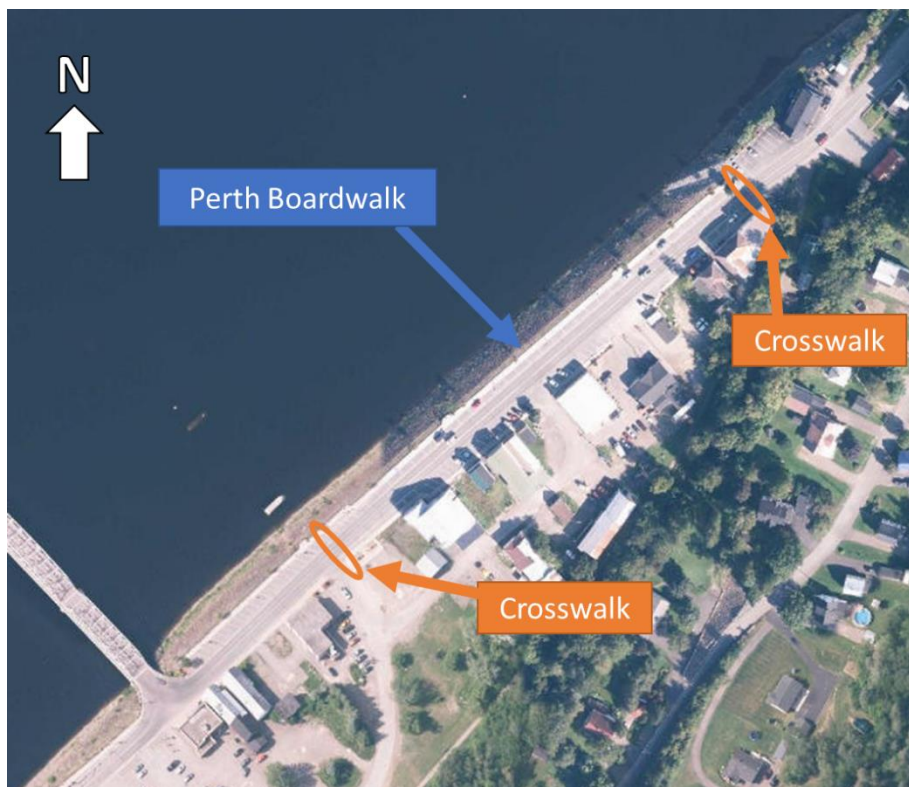
Figure 9: Perth Boardwalk Crosswalk Options

The Perth Boardwalk to the north of the bridge, along Perth Main Street, is a 310 m stretch of sidewalk lined with park benches, picnic tables, and scenic views of the Saint John River. Currently, there are no crosswalks that provide access to the boardwalk. We were asked to review the need for crosswalks to provide access to the boardwalk and to recommend where they should be located. A photo of the Perth Boardwalk area is shown in Figure 21 in Appendix A.

There are two main reasons why pedestrians would cross Perth Main Street in the vicinity of the Perth Boardwalk: to get to/from their parked car on the west side of the roadway and to access the boardwalk for recreational purposes. People crossing from their car to a store, or vice versa, are more likely to cross at their convenience than detour to a crosswalk, whereas recreational users are more likely to have a walking route that could incorporate crosswalks by design.

Following the above discussion, **we would recommend that crosswalks be added at the north end of the boardwalk and at the intersection with Station Road** as shown in Figure 9. A crosswalk at the intersection with the bridge is not recommended at this time as per the previous discussion of that intersection. It is recommended that both crosswalks have curb extensions installed to reduce crossing distances, zebra markings, and ground mounted signs (RA-4).

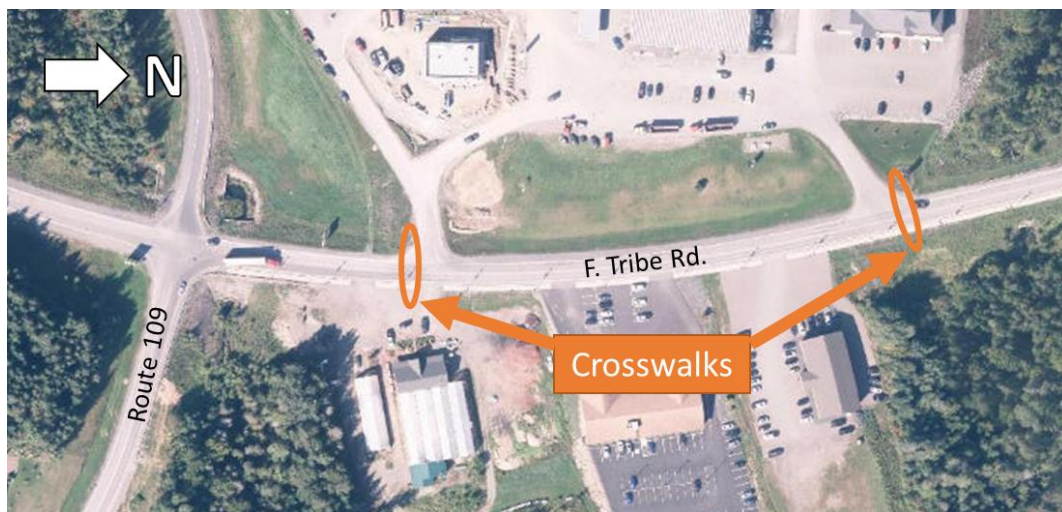
Figure 10: F. Tribe Road Crosswalk Options

F. Tribe Road, between Fort Road and Route 109, has seen significant commercial development on the east side over the last decade with more planned development to come. The roadway currently has a sidewalk on the east side with no crosswalk connections to reach the west side. We were asked to review how safety could be improved for pedestrians crossing the roadway. Site photos of the area are shown in Figure 22 through Figure 24 in Appendix A.

In terms of crossing opportunities, **we recommend installing crosswalks at both driveway accesses to the plaza on the west side** as shown in Figure 10. While pedestrian activity was not observed at the site during our site visit, crosswalks at these driveways should be on the natural desire lines for pedestrians, which is where they would naturally cross the roadway to access the development regardless of crosswalk location. The crosswalks at each driveway should have ground mounted signs (RA-4), pedestrian crosswalk ahead signs (WC-2), and zebra markings.

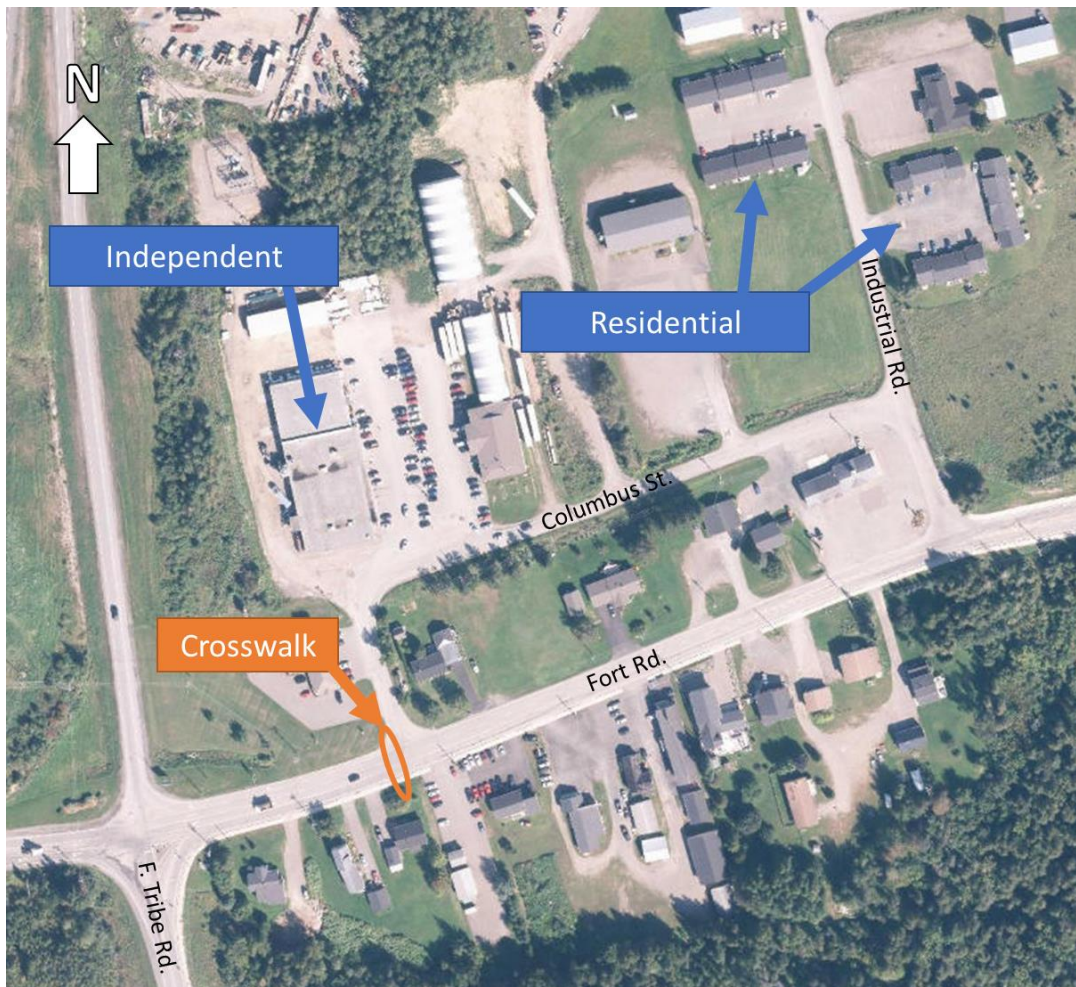
Figure 11: Fort Road @ Columbus Drive Crosswalk Option

Columbus Street (near the Independent Grocer) is a popular pedestrian crossing location for people moving between the commercial areas by the Independent and along F. Tribe Road. One of the generators for this traffic is multi-family residential units along Industrial Drive that are home to temporary workers who help serve local industries. A photo of the area is shown in Figure 25 of Appendix A.

To make drivers more aware of potential pedestrian crossings in the area, **we would recommend that a crosswalk be installed on the west leg of this intersection**, as shown in Figure 11. While sight distances were not explicitly evaluated during our site visit, the area is relatively flat with no major view obstructions and is about 100 m east of the intersection of Fort Road and F. Tribe Road. Installing a crossing at this location is preferred to connecting to one at the intersection of Fort Road and F. Tribe Road to align with the existing infrastructure and likely desire line of pedestrians. A crosswalk at this location should have ground mounted signs (RA-4), pedestrian crosswalk ahead signs (WC-2), and zebra markings.

Sidewalk to connect the multi-family residential units on Industrial Park to this crosswalk (via Columbus Street) should be installed in accordance with the Village’s Sidewalk Policy.

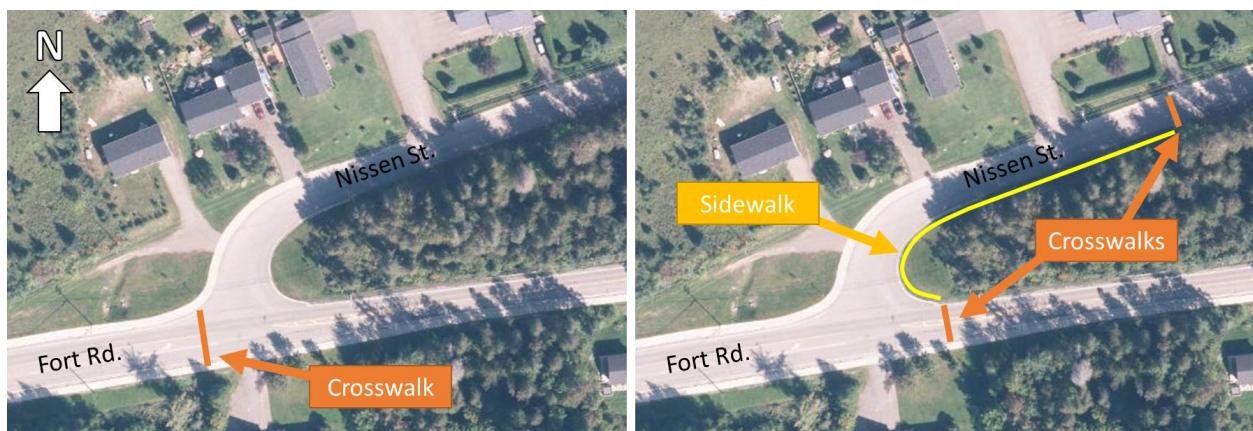
Figure 12: Fort Road @ Nissen Street Crosswalk Options

Nissen Street is the access road to Perth-Andover Middle School and has sidewalk along one side to provide a safe space for students to walk to school. The school is separated from the main residential area of the Village by Fort Road, which does not have any pedestrian crosswalks to facilitate students walking to school. This situation was identified as a concern due to the risk to students crossing the road primarily when it is dark and/or when there is fog in the morning. Photos of the area are shown in Figure 26 and Figure 27 in Appendix A.

Sight distances were not explicitly evaluated during our site visit, but based on the photographs taken during the site visit and collecting measurements from Google Earth it appears that there is sufficient stopping sight distance and decision sight distance for a crosswalk across either the east leg or west leg of the intersection for a 50 km/h roadway¹.

Installing a crosswalk at the west leg of the intersection provides the best connectivity to the existing sidewalk on Nissen Street but has a long crossing distance of about 16 m. A crosswalk at the east leg has a shorter crossing distance of about 11 m but a second crosswalk would be required to connect to the existing sidewalk on Nissen Street, either at the intersection or further along Nissen Street. These alternatives are illustrated in the figure below; note that the additional crosswalk on Nissen Street is shown about 90 m from the intersection to provide adequate sight distances. **We would recommend that one of these two crosswalk alternatives be implemented to facilitate students walking to school.** At a minimum the crosswalks at Fort Road/Nissen Street should have ground mounted signs (RA-4), pedestrian crosswalk ahead signs (WC-2), and zebra markings, while any crosswalks along further along Nissen Street would require school crosswalk signs (RA-3) and zebra markings.

Since the primary concern was for students crossing in poor visibility conditions, a typical ground mounted crosswalk sign setup may not provide a sufficiently safe crossing environment for students. **The Village should consider installing a Rapid Rectangular Flashing Beacon (RRFB) crosswalk at this location** to provide additional visual guidance to drivers when the crosswalk is being used by pedestrians. A typical RRFB installation costs in the ballpark of \$20,000 to \$25,000 including all hardware, lights, batteries,

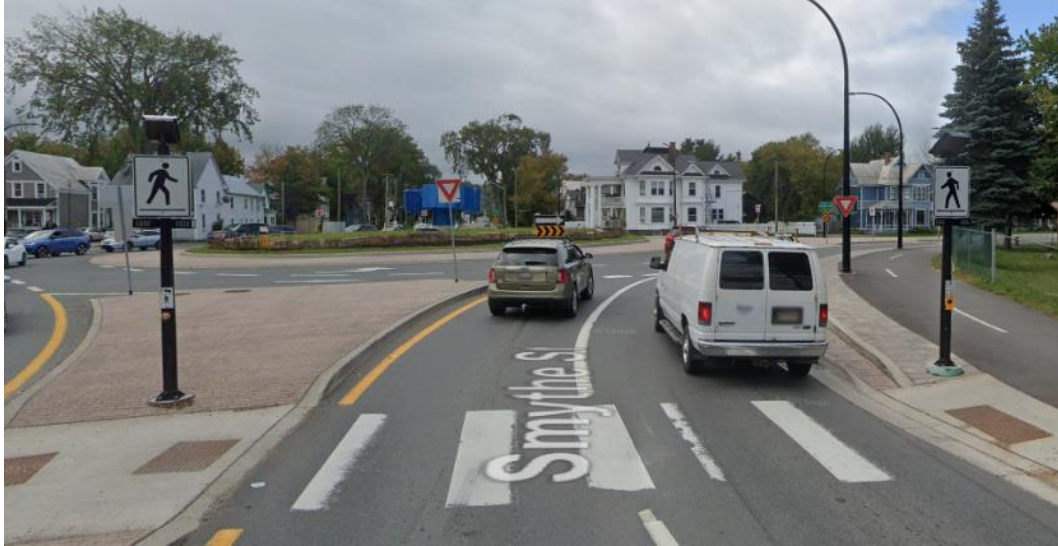
Figure 13: Example RRFB Setup

mounting poles, signs, etc. An example of an RRFB setup is shown in Figure 13. Note that an RRFB would not be required at the crosswalk on Nissen Street shown in Figure 12.

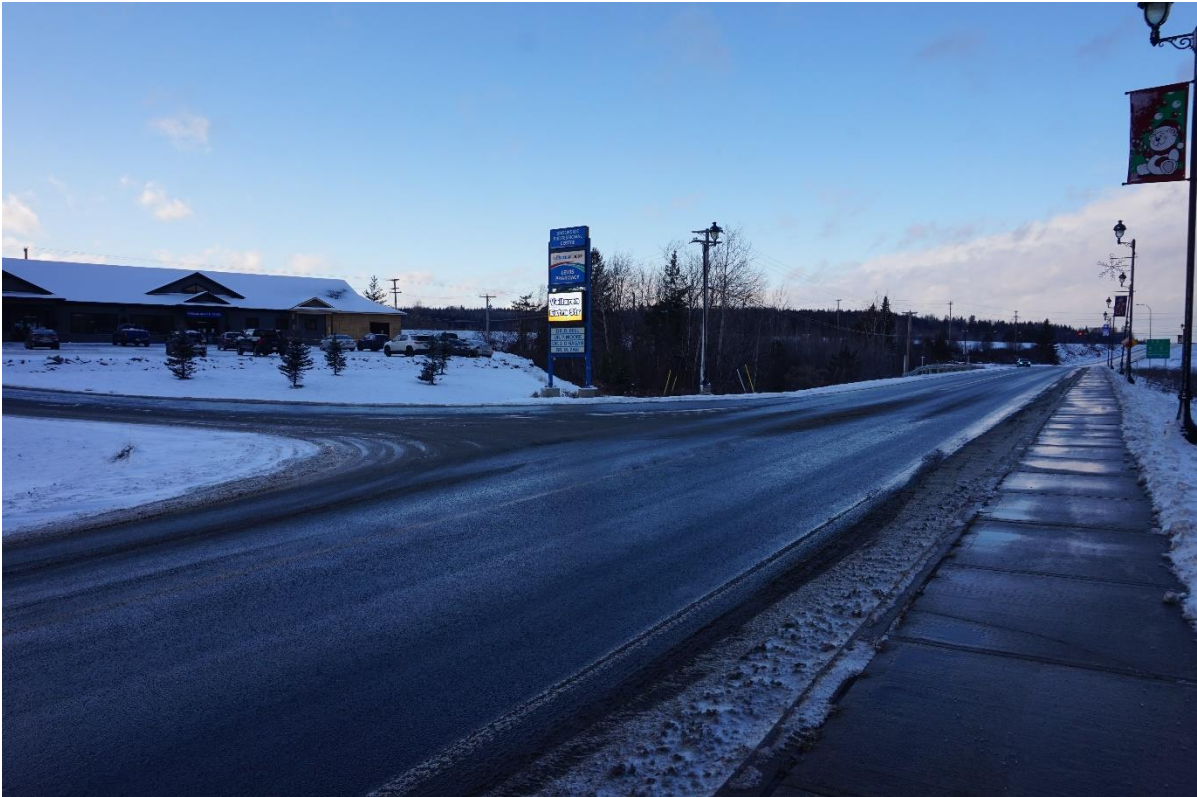
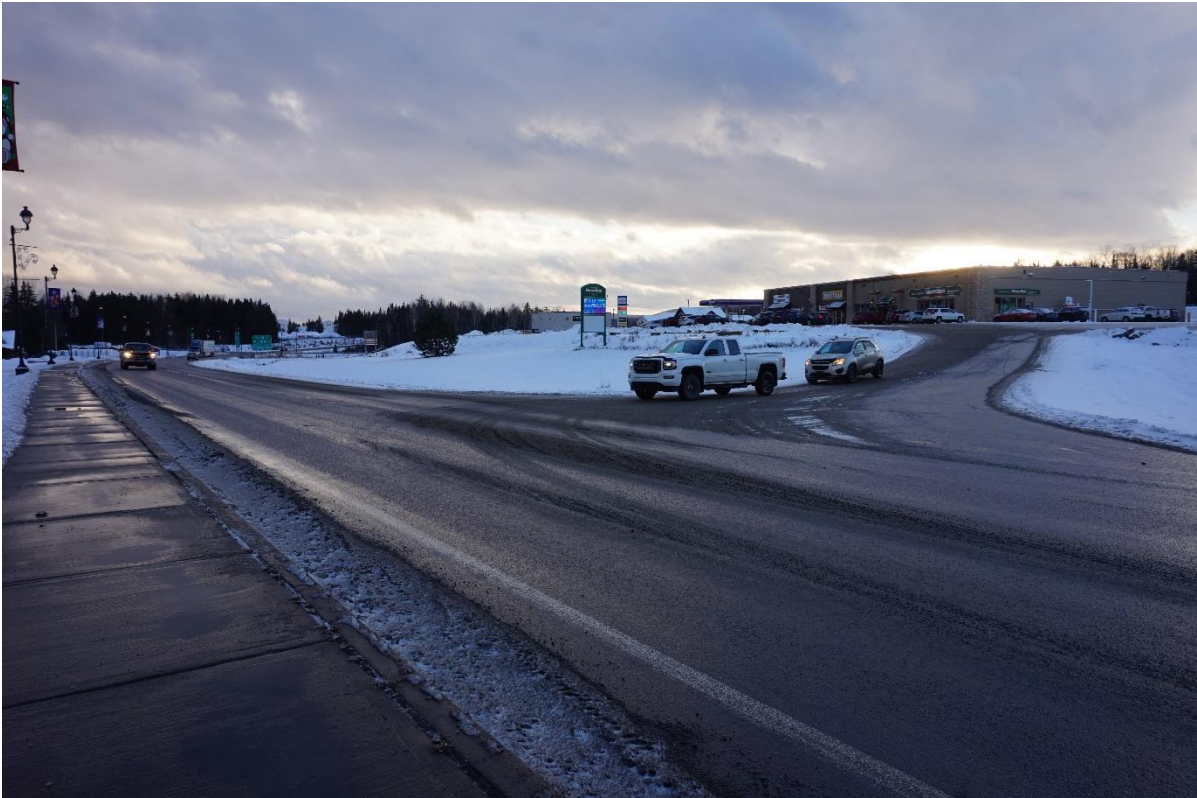
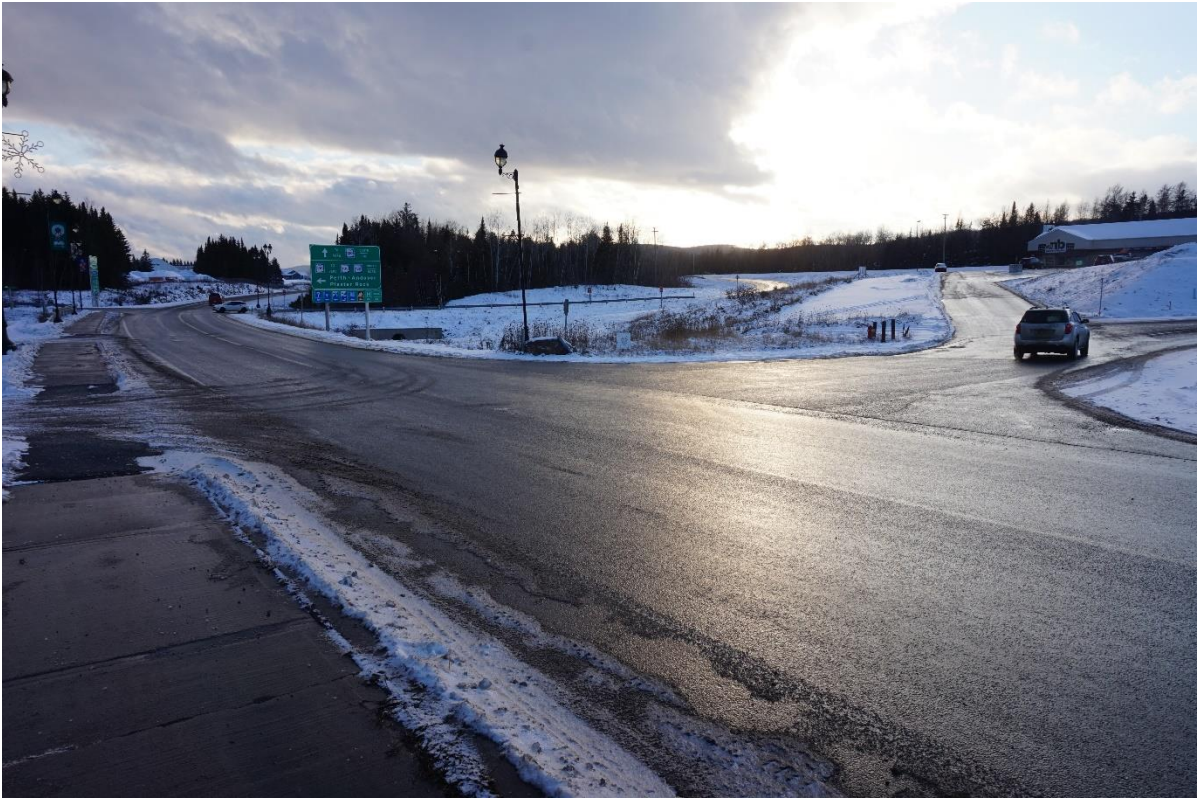
Figure 22: F. Tribe Road North Driveway - Northbound View

Figure 23: F. Tribe Road North Driveway - Southbound View

Figure 24: F. Tribe Road South Driveway - Southbound View

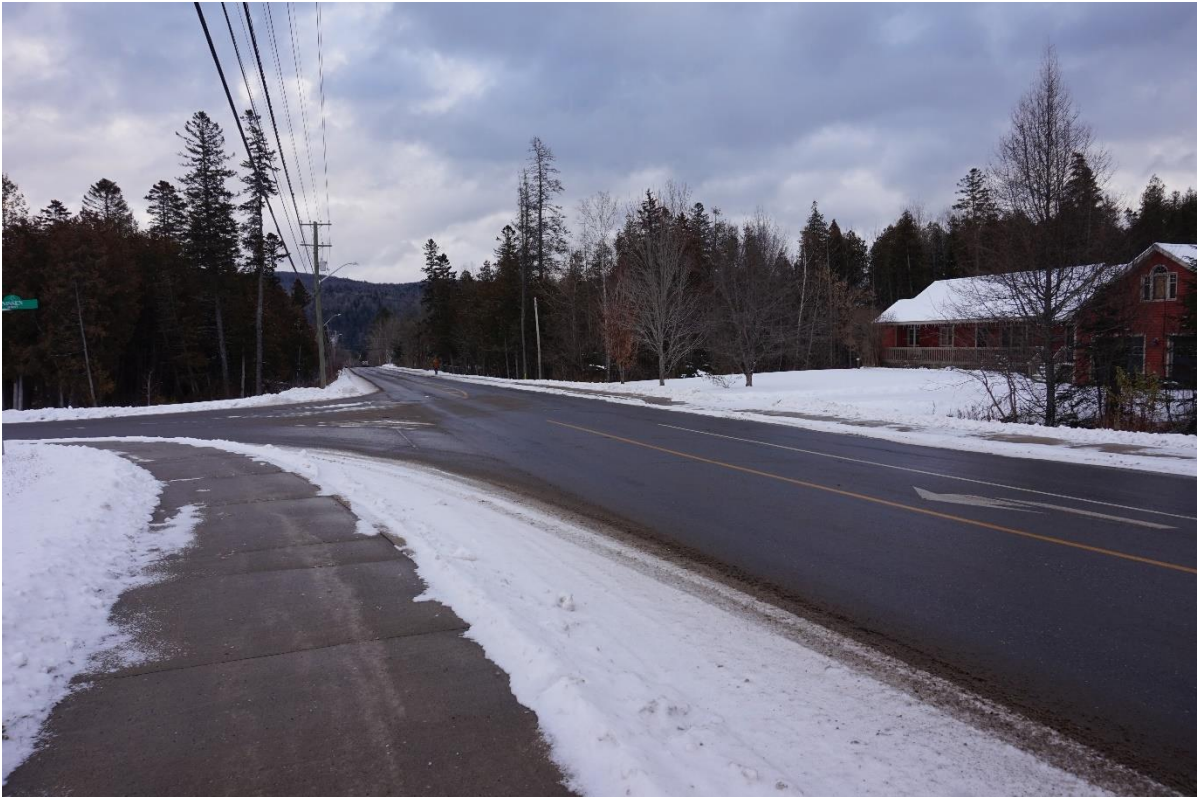
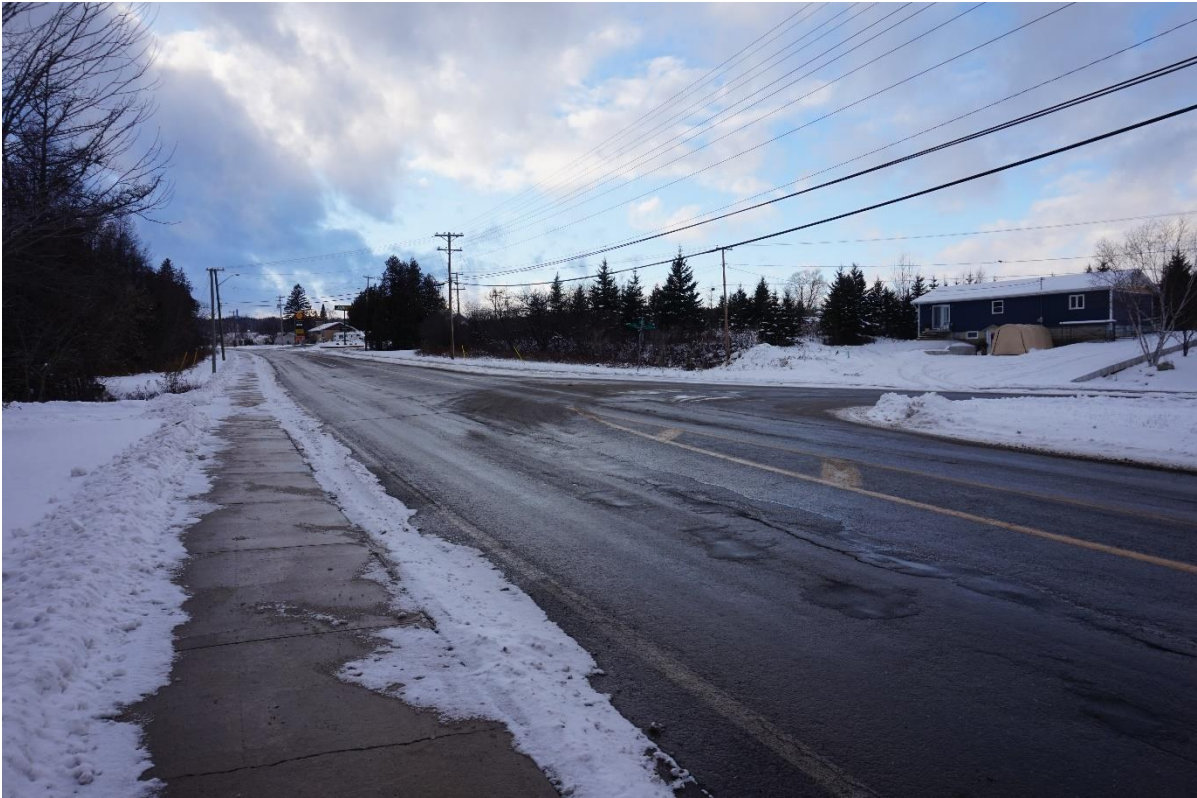
Figure 26: Fort Road @ Nissen Street - Eastbound View

Figure 27: Fort Road @ Nissen Street - Westbound View
